Tech Tip Bulletin
031511

Premature Tie Rod End Failure

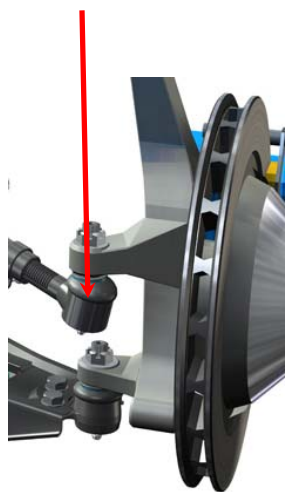
Premature tie rod end failure is commonly caused by contaminants leaking past the OE boot retaining ring. The original design is non-serviceable and unable to flush out contaminants.

Water gets trapped in the lip of the dust boot and seeps past the retaining ring.

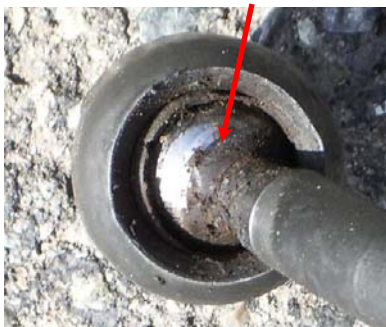
- With the vehicle on the ground, rotate the steering wheel back & forth and observe the tie rod end movement. If there is any perceptible movement, the tie rod needs to be replaced.
- Lift the bottom of the boot and inspect the tie rod stud. If there is any sign of corrosion the part needs to be replaced.
